Indigenous Revival of PSM-EIKA Cloud Radar for Core Monsoon Zone Cloud Observations

Technical Report

ESSO/IITM/ART/TR/02(2026)/208

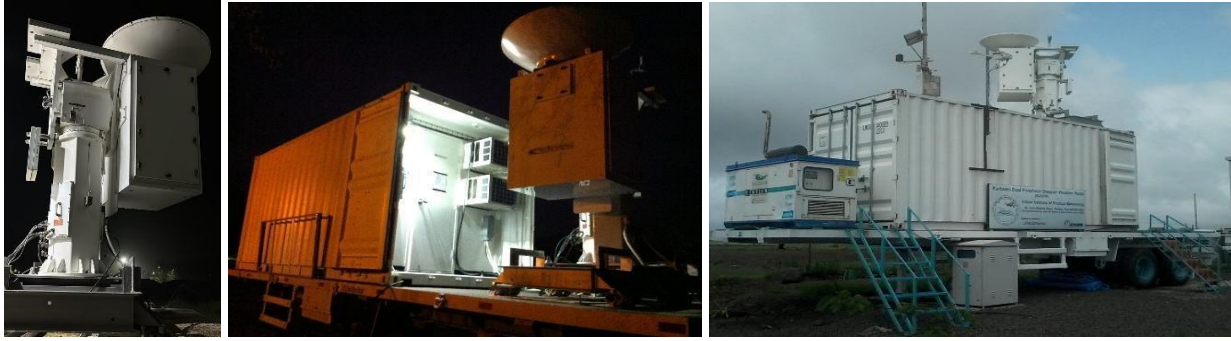
Figure 1. i. 1.2 m antenna cum RDS mount on Pedestal, 20 ft Container, and KaSPR on wheels photographs

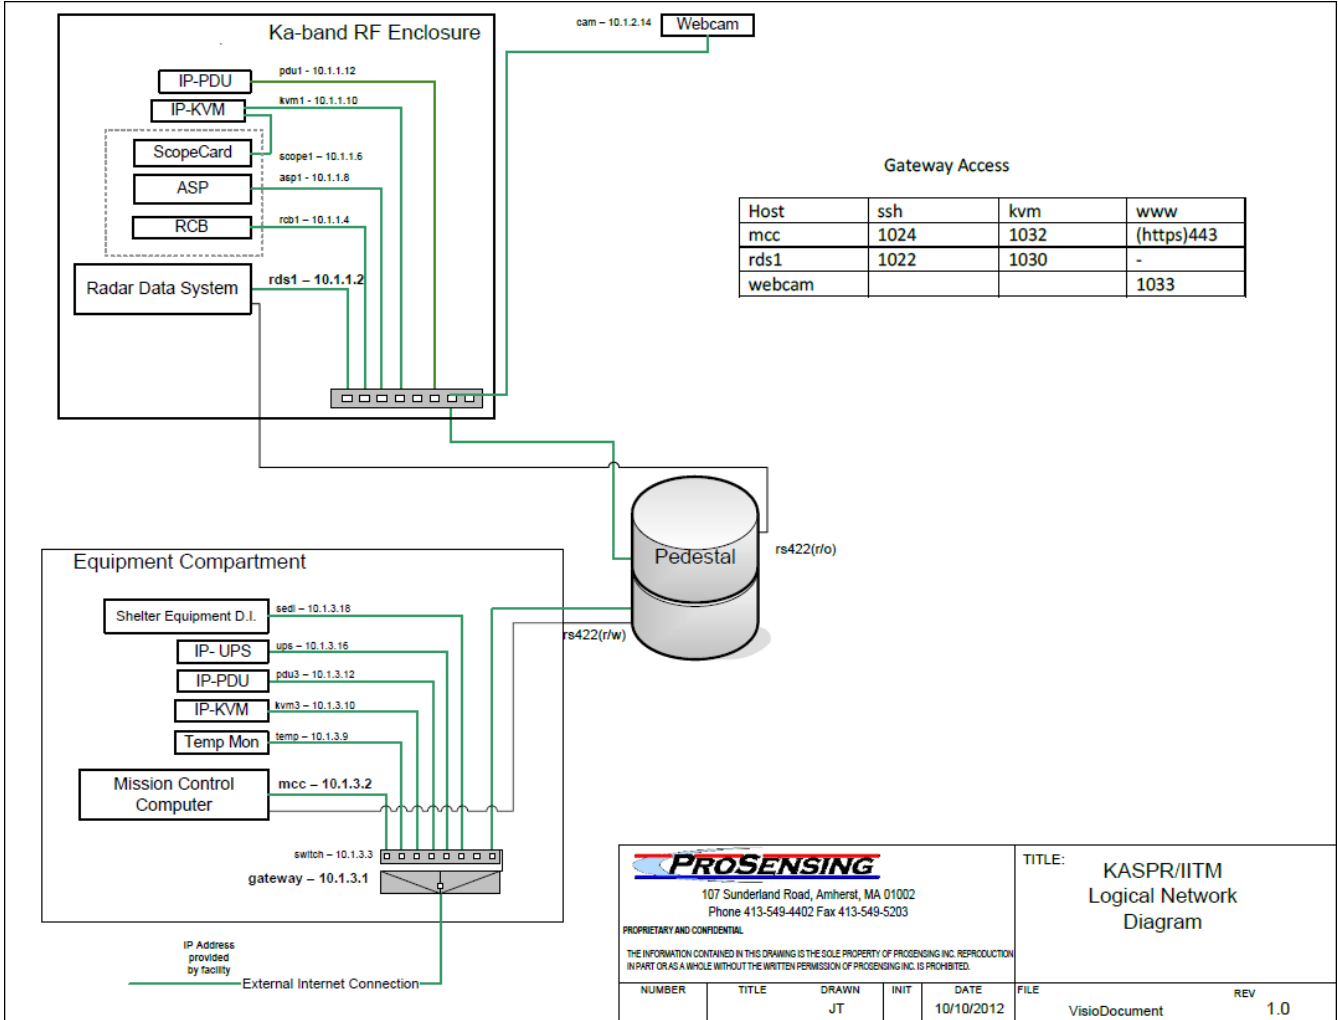
Figure 1. iii. KaSPR logical network diagram.

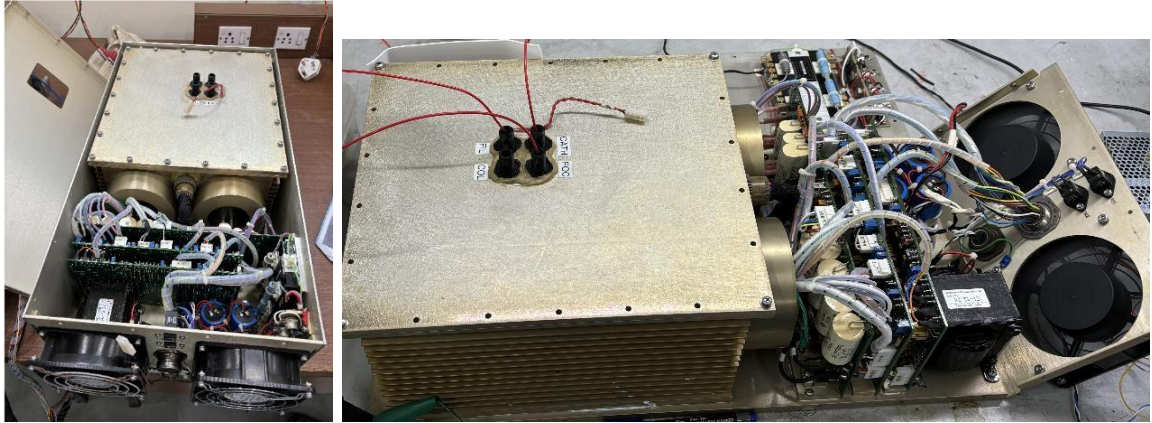
Step 1: External Facility Testing. The dismantled PSM was tested with the Control Monitoring Unit (CMU) at SAMEER, Mumbai.

Observation: The Issue could not be isolated precisely during CMU testing.

Figure 3. The PSM PCB & IC level testing at IITM, Pune, and M/s. Grow Controls Pvt. Ltd, Hyderabad.

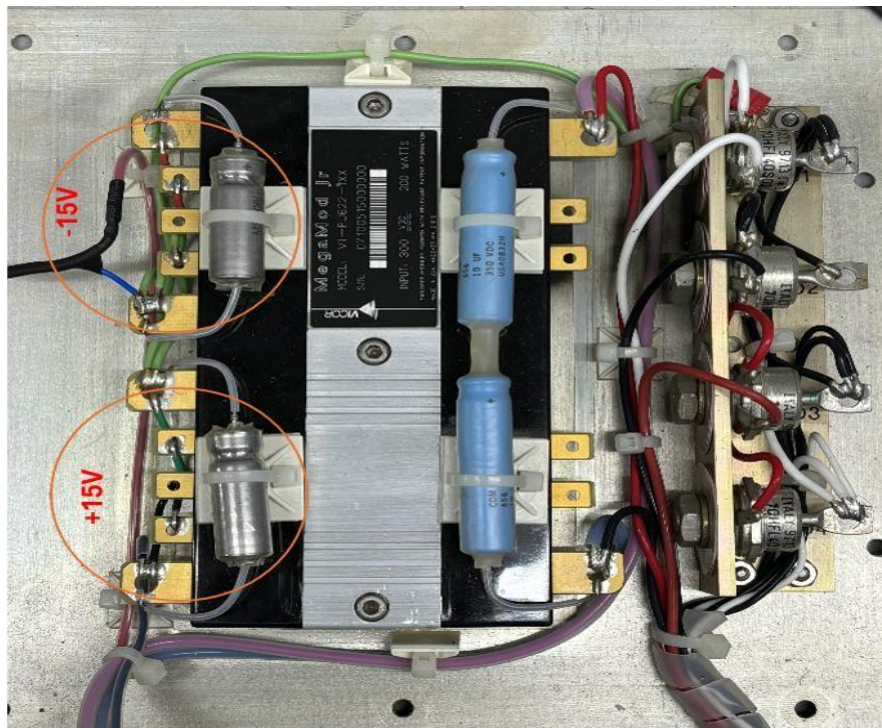
- The fault was traced to a failed isolated DC-DC converter: VIPJ622-1XX, as shown in Figure 4 below.

Figure 4. The Isolated DC-DC converter: VIPJ622-1XX (Circle marks indicate $\pm 15V$ supply outputs)

- The DC-DC converter will provide a $\pm 15V$ supply for other PSM power modules to activate the high-power system, which will generate voltages for Filament, Cathode, Focus beam, and Collector.
- Identified that the DC-DC converter is giving out only +15V supply and 0V supply instead of -15V supply; measured with Digital Multi-Meter (DMM) as shown in Figure 5 below.

- Replace faulty converter with a suitable chassis-compatible component: VIPJ622-IXX (DC-DC converter for $\pm 15V$ supply).
- Develop a permanent in-chassis regulated $\pm 15V$ supply module: Perform extended continuous operation testing under real field conditions.

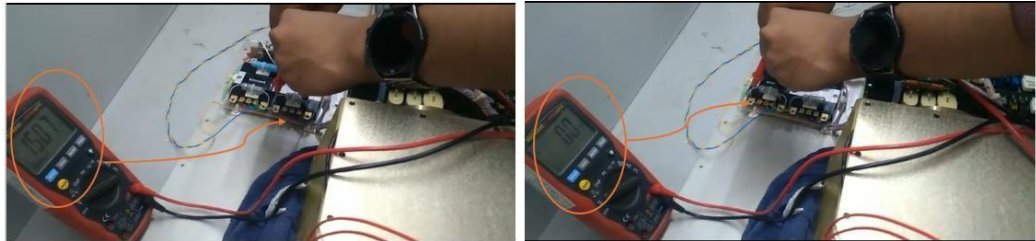
Figure 5. Isolated DC-DC converter outputs testing with DMM. The positive output power supply shows +15V, and the Negative output power supply shows 0V as marked in circles.

The converter failed to supply the -15V output required to enable modulator control and sequencing.

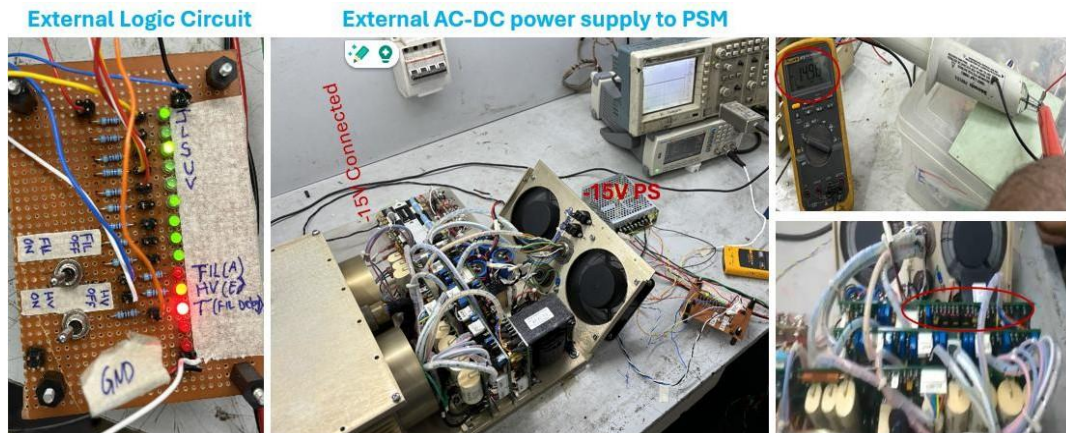
Figure 6. External powering and validation of the PSM logic circuitry using an external AC–DC supply (–15 V). The DMM verifies a stable –14.96 V input (top-right) and illuminated LEDs on the PSM PCB (bottom-right) confirm successful power delivery and logic activation.

Since replacement part availability was limited, an indigenous workaround was implemented: the PSM logic path was bypassed, and -15V was applied externally using an AC-DC power supply, as shown in the Figure 6 below. This approach enabled validation of the system response and successful recovery of modulator outputs with a negative power supply of -14.96V.

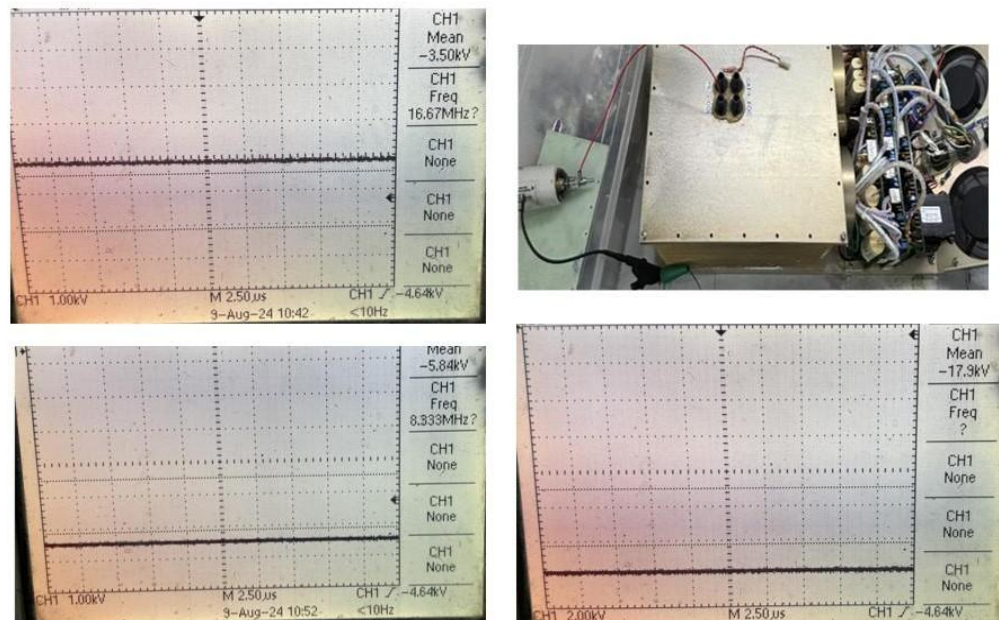
Figure 7. Measured PSM output voltages with an external DC power supply using an oscilloscope.

During indigenous troubleshooting and restoration at IITM, the PSM output voltages were checked using appropriate high-voltage probing and oscilloscope monitoring. The measured values were within expected operational levels, with grid voltage ~ -3.5 kV and collector voltage ~ -5.8 kV, indicating that the modulator was generating the correct bias. The cathode-related high-voltage output was also observed within the expected operational range during testing (e.g., ~ -17.9 kV in the recorded waveform), as shown in Figure 7 below, confirming that the restored PSM was capable of delivering the required voltages for EIKA operation, as given in Table 1. These measurements, consistent with CPI's typical operating values, helped validate that the transmitter power supply chain had returned to a safe and functional state suitable for KaSPR field deployment. The troubleshooting process is documented in the flowchart as shown in Figure 8 below.

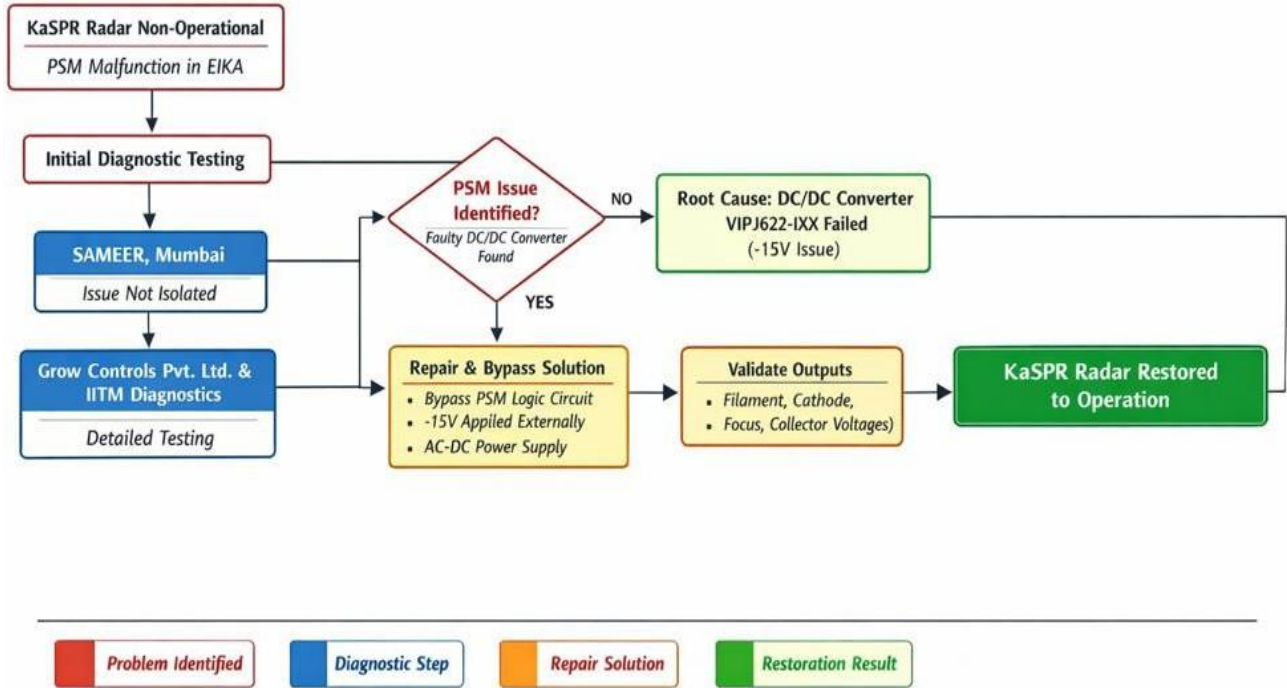
Figure 8. Flowchart: The revival process of KaSPR-Indigenously.

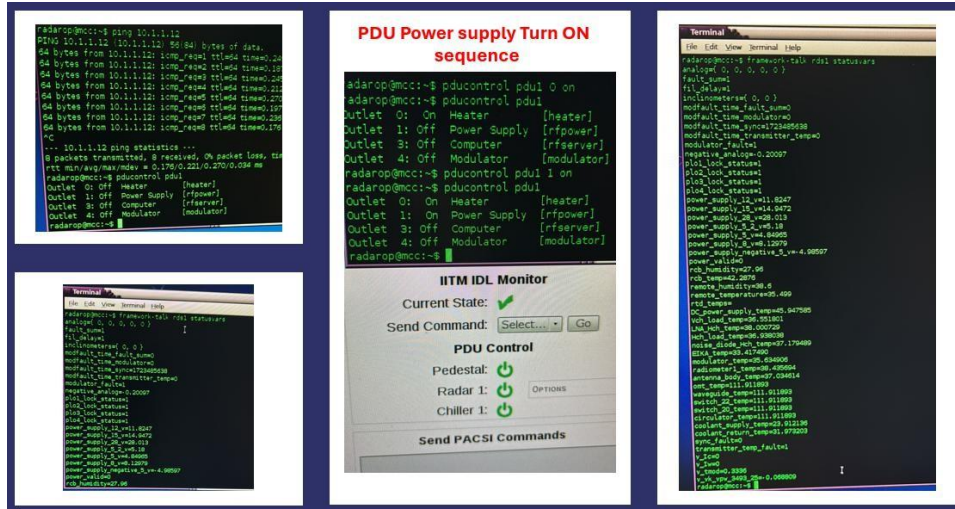
- Following the reintegration of the KaSPR subsystems, the initial power-up attempts revealed multiple setbacks, primarily due to the PDU outlets not being enabled for critical loads such as the heater, RF power supply, computer/server, and modulator (as indicated in the PDU control/turn-ON sequence screen shown in Figure 11).

Figure 11. The attached screenshots show the PDU power supply turn-on sequence for enabling power to the heater, RF power, Computer, and Modulator.

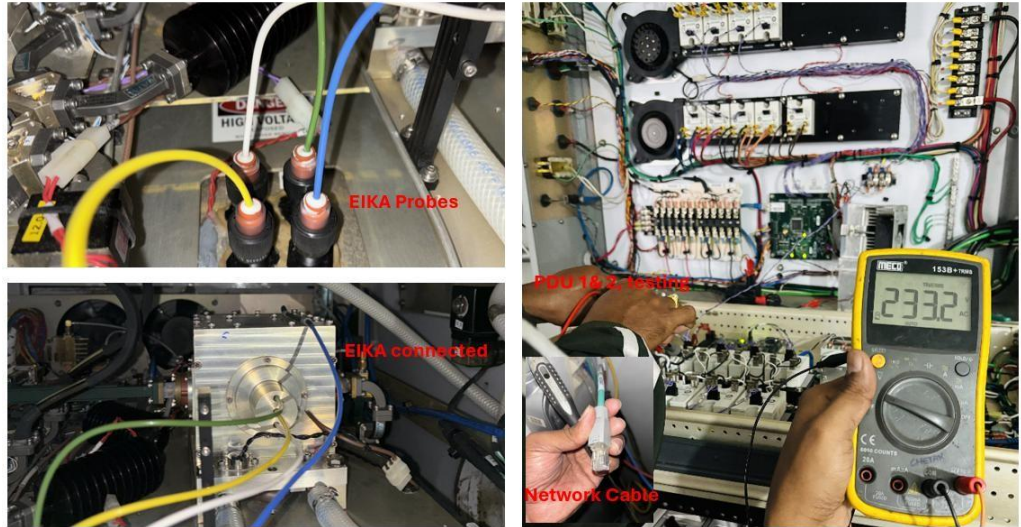
Figure 12. EIKA reintegration showing high-voltage probe connections (cathode, filament/heater, grid, and collector) and verification of transmitter section readiness before system power-up. Electrical validation of PDU-1 (shelter) and PDU-2 (RF box), including ~233.2 V AC supply verification, prior to enabling KaSPR subsystems. Network communication restoration between MCC–RDS and RF modules.

- To resolve this, both PDU-1 (shelter) and PDU-2 (RF box) were systematically verified, and stable mains availability of ~230 V AC was confirmed during testing (Figure 12 showing multimeter and PDU testing). After successful power validation, the EIKA was remounted and connected using the four high-voltage probes (cathode, filament/heater, grid, and collector connections) as shown in the transmitter section images. During this stage, a DC centrifugal fan malfunction was also identified (fan shown in Figure 12) and rectified to ensure proper thermal management. Subsequently, a communication issue occurred due to faulty network cable/network switch connectivity, which was resolved by reconnecting and externally validating the network path to establish stable communication between the Master Control Computer (MCC), Radar Data Server (RDS) and RF enclosure modules (network cable indication Figure 12).

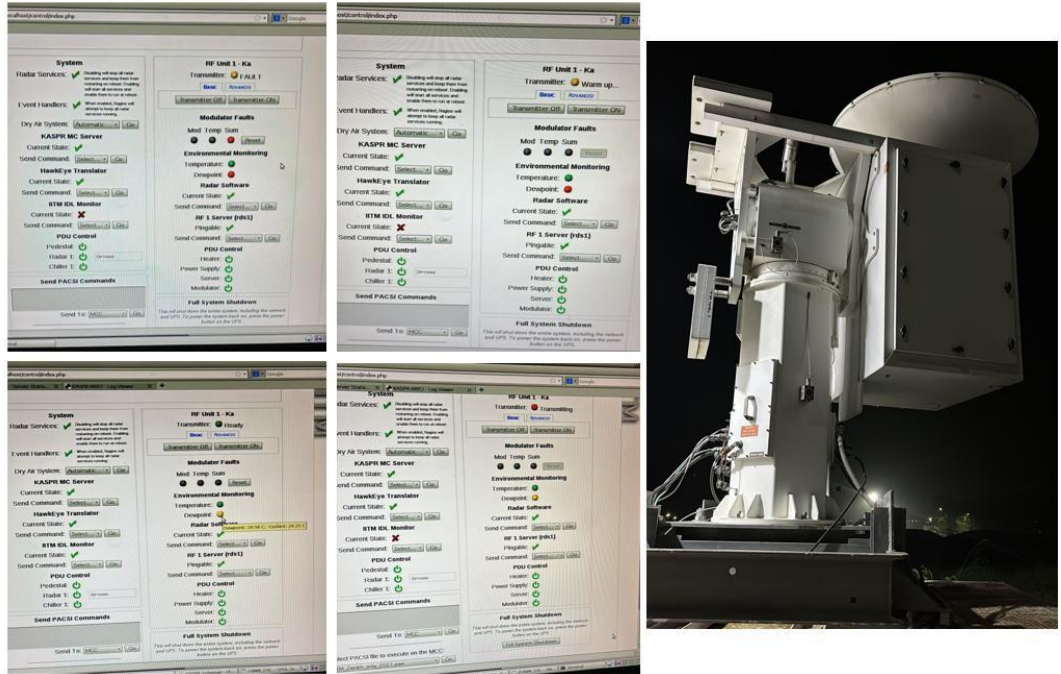
- With all hardware, power, cooling, and network links restored, the complete system was started up with online support from M/s ProSensing Inc., USA. Immediately after boot-up, the system displayed a FAULT SUM condition due to a dew point exceeding the permissible limit (web control interface figure). The team waited ~1–2 hours for the dry-air system to reduce humidity, after which the dew point returned to within limits, and the EIKA sequentially transitioned to Warm-up mode and then to the READY state for transmission (status screenshots shown in Figure 13).

Figure 13. Dew point exceeded, triggering FAULT SUM, EIKA warm-up, and a READY state transition, confirming stable modulator outputs and transmitter readiness for radiation.

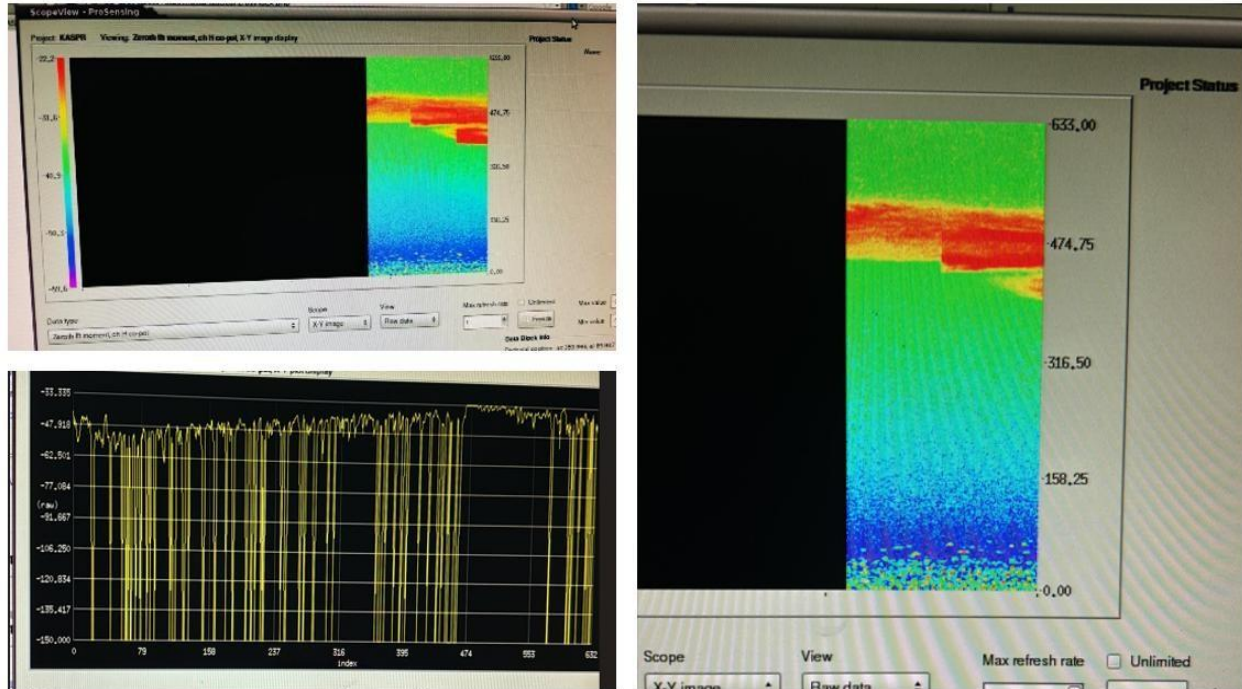
Finally, the transmitter was enabled, and successful radiation was confirmed as the first return signal appeared in the ScopeView display, with the zenith-pointing mode clearly showing cloud layers as shown in Figure 14, demonstrating the successful revival of KaSPR from a non-operational to fully operational state for ISM cloud research over Central India (ART-CI). The engineers from M/s ProSensing Inc., USA, appreciated the indigenous efforts of the IITM team in restoring the radar system to operational condition. Post-revival, radar is capable of High-resolution vertical profiling of clouds, Continuous monitoring in HTI (zenith) mode, scanning observations in PPI/RHI modes, and capturing cloud evolution and microphysical signatures during ISM conditions.

Figure 14. The screenshots show the ScopeView first-signal detection after revival and a Zenith-pointing mode (HTI) observation showing layered cloud echoes after the KaSPR system was brought back to transmitting condition, demonstrating operational cloud-monitoring capability.

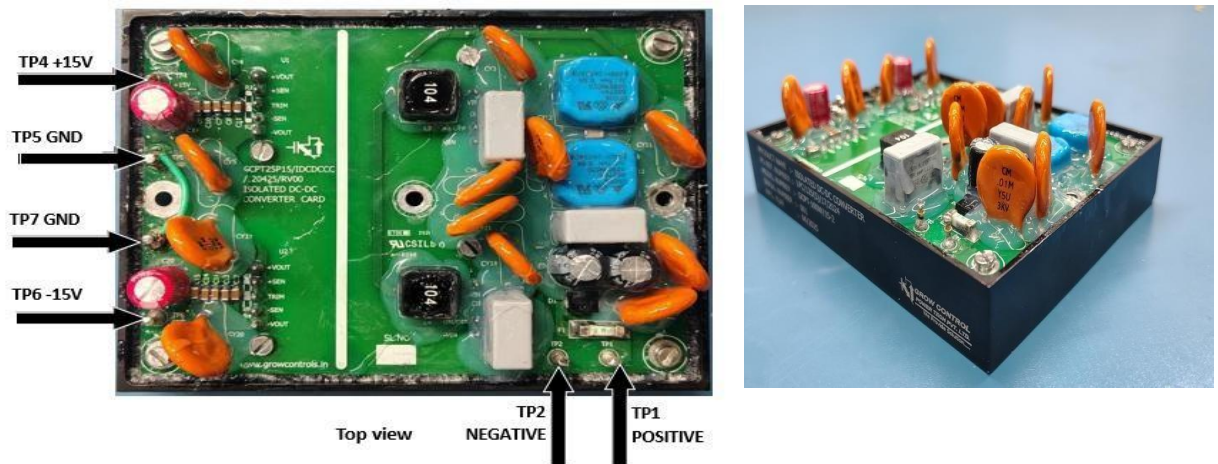
Figure 15. The top view and isometric view of the Indigenous developed DC-DC converter for the $\pm 15V$ supply VIPJ622-IXX.

- M/s Grow Controls Pvt. Ltd, Hyderabad, successfully developed the VIPJ622-IXX (DC/DC converter for $\pm 15V$ supply) indigenously under the support and guidance of IITM ART Radar Team. The top view and isometric view of the Indigenous developed DC-DC converter for the $\pm 15V$ supply VIPJ622-IXX as shown in Figure 15 below.

- The indigenously developed Power module has been tested successfully and reinstalled in KaSPR, and it is working fine.
